Building Industry and Earthquake Damage in the Arab region

**Presented to Seismic Base isolation workshop (organized by the National Innovation
Office and the Steering Committee of the KMFB/W
Date : April 24,2013**

Prepared and Presented by Dr. Ramez Raslan

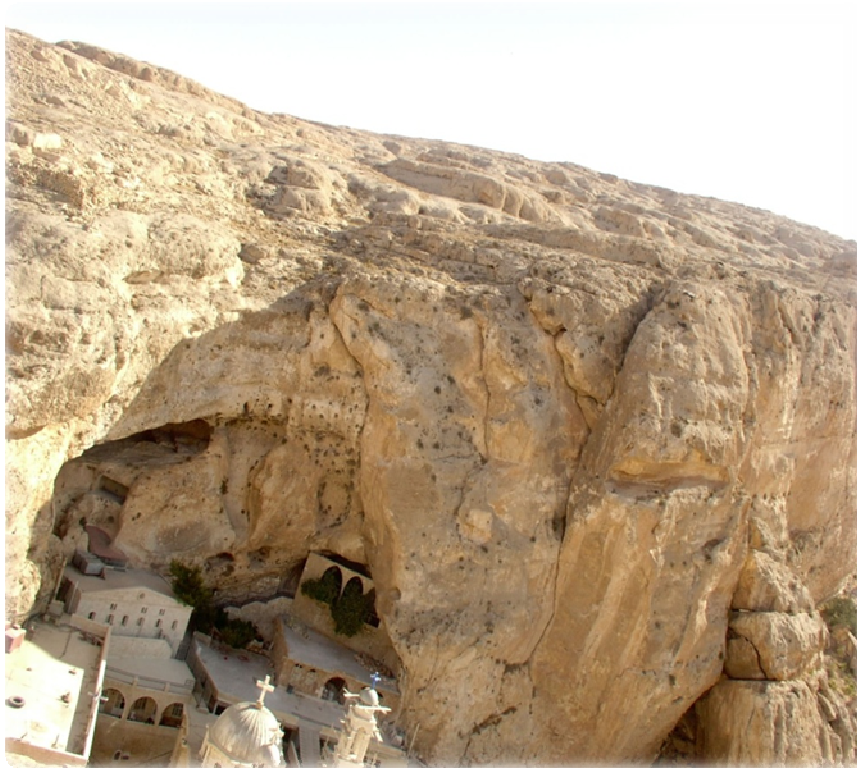
Maloula Monastery

Since Christianity shined from Nazaret, Maaloula Christians built their first church in a mountain cave.

Pre historic E.Q caused the fall of a giant rock. The sister rock has apparent cracks causing everybody to fear a disastrous fall.

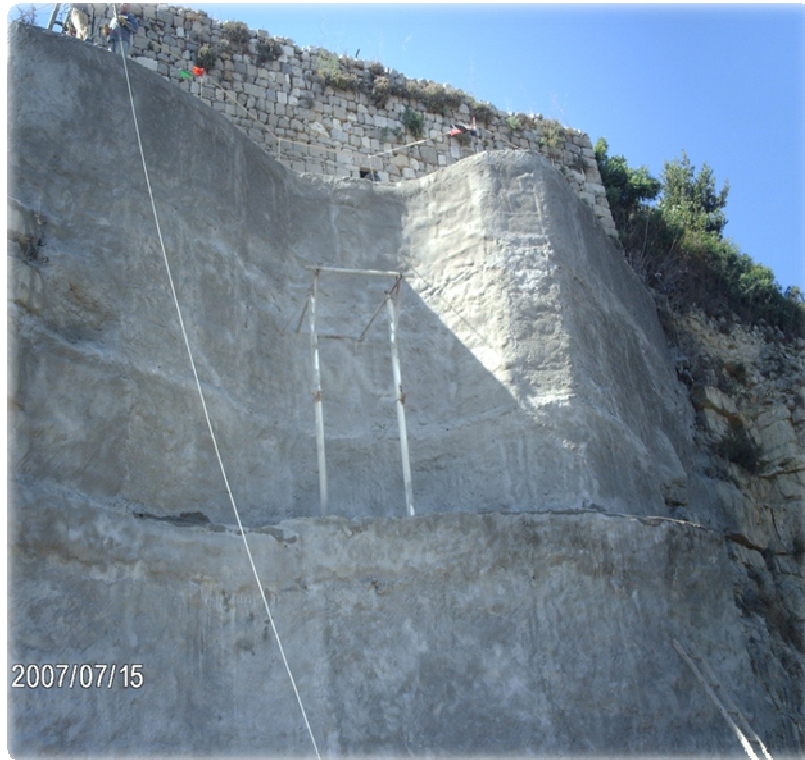
Kadmous Citadel

A refuge of an old rebellion leader constructed the castle on top of a cliff.

The cliff fell as a result of an E.Q on houses located down the hill, whose residents belonged to a certain religious sect. It was feared that the residents might assume the fall was initially created by residents of the other sect who lived uphill.

We had to nail the rocks of the hill and construct a preventive wall.

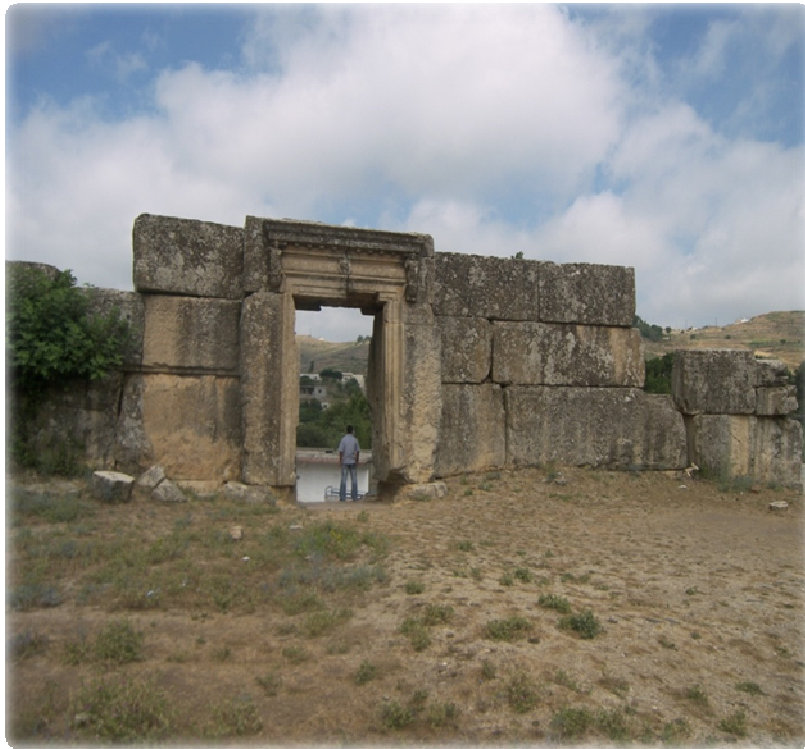
Salamon Citadel

Was built 2 centuries back using about 30 tons stones laid on top of each other to form walls.

As a result of a light earth quake few stones fell blocking the road.

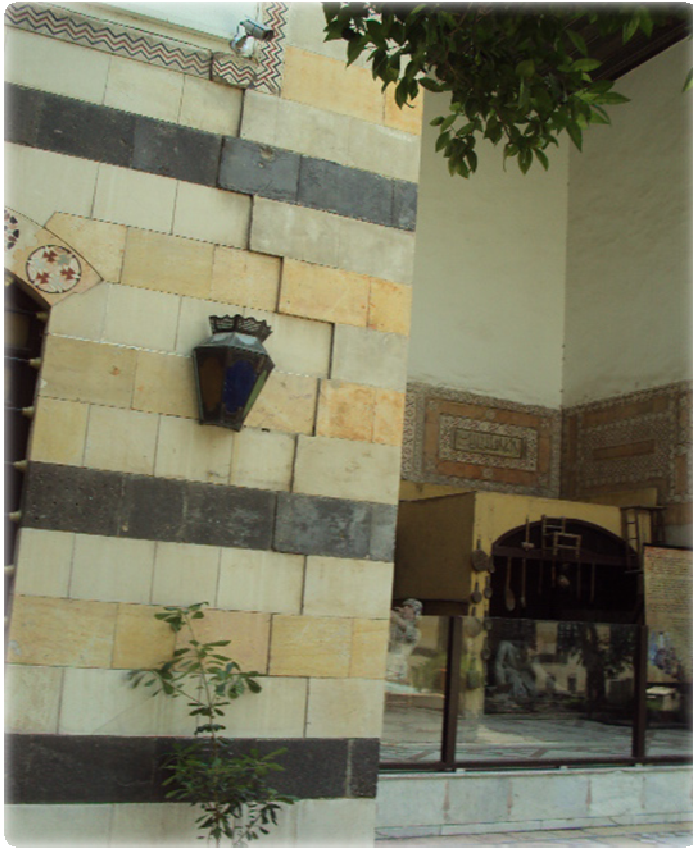
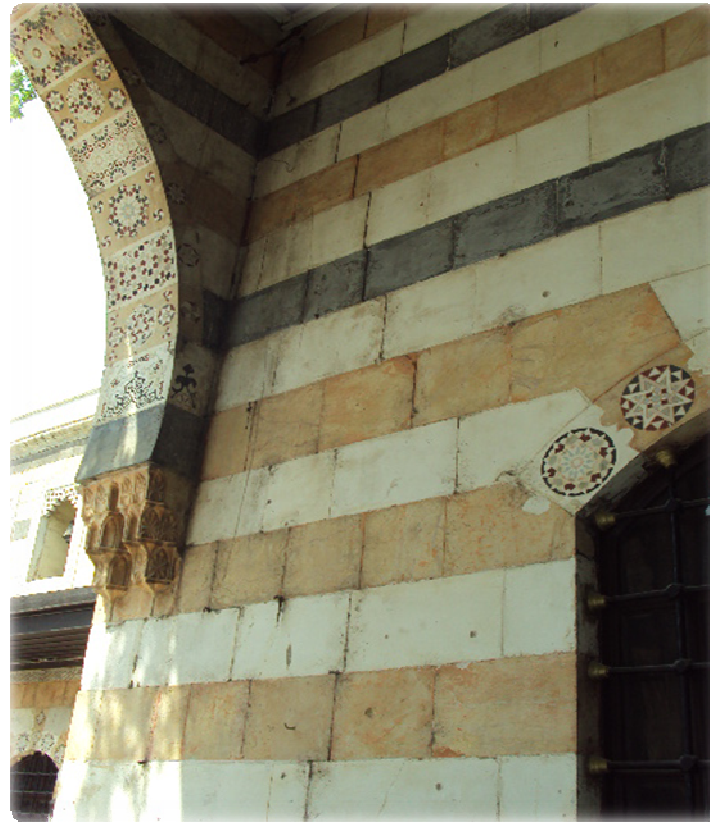
Built in mid 19th century of rubble stone and mortar with finished stone facing. No apparent resistance of lateral forces and because of relatively high (7 m high) one storey construction lot of cracks appear on the walls.

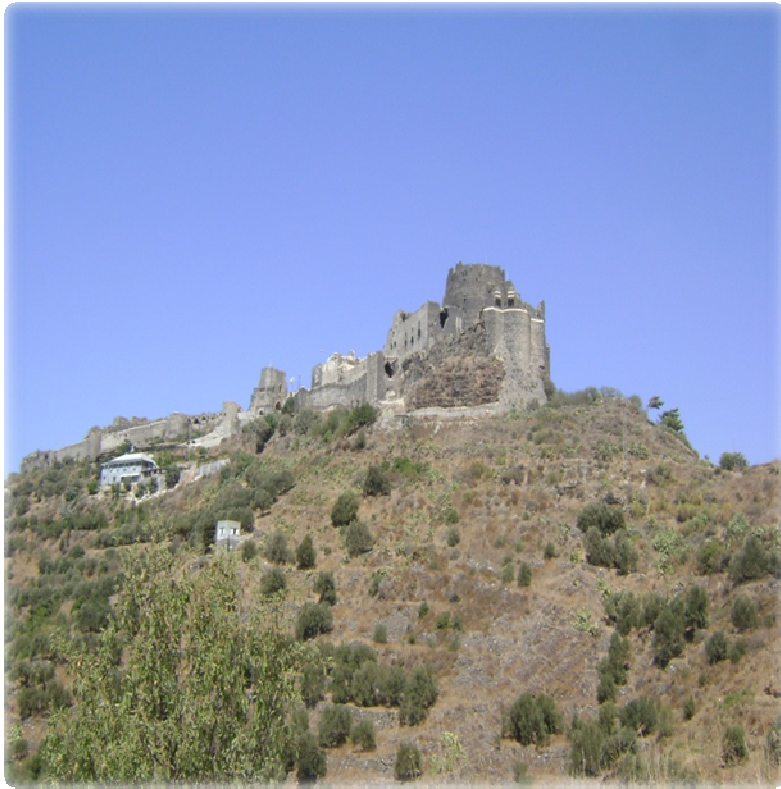
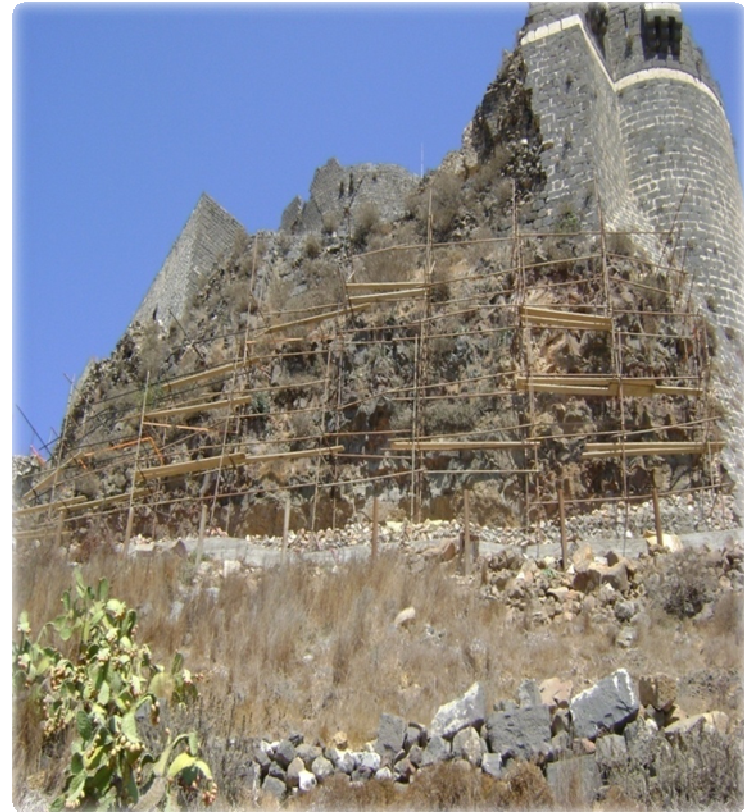
Built on a hill through the ages was subject to natural erosion, created worries of a fall down.

Thus initiating the need to constructing slope stability aids for additional protection.
